UNIQUE WAYS OF REJECTION CONTROL – SOME CASE STUDIES WITH IMPROVEMENT THEMES

Arun P. Dongrey

M/s. Dongrey & Associates,

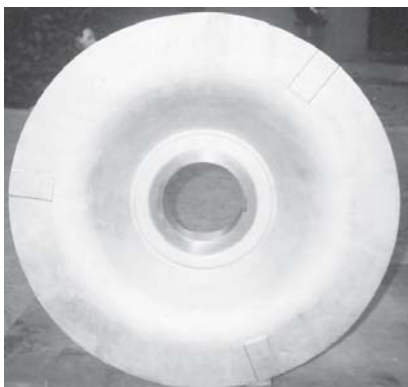
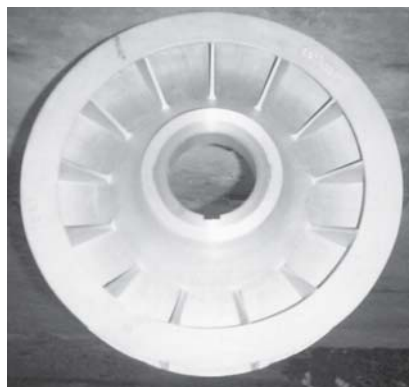
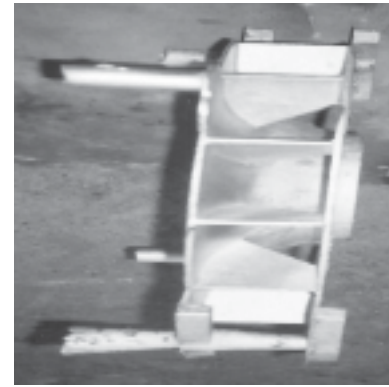
The fan under study was made in three moulding boxes, thus avoiding the usage of core. The casting with 7 vanes invariably gave indications of gas holes, when viewed through x-rays. Reason of gas hole at the juncture of the vane and the upper shroud could not be visualised first, as there was no core used in the fan. On further investigation, however, it was understood

that the green sand in between the upper and lower shrouds would give out gases including water vapour. If these gases did not have access outside the mould, the same would lift up and show the gas holes at the upper shroud as shown in the radiographs.

The green sand between the two shrouds eventually gave out water vapour and other gases, when pouring started. Earlier, these gases went up and the radiograph showed signs of gas inclusion at the interface of the vane and the upper shroud. Applying wax rope at each pocket allowed the evolved gases to go outside the mould through the cavity created at the wax rope location.

Wax ropes of 10 mm diameter were inserted while mould making, two each between each shroud, ensuring that the rope did not touch any part of the pattern. Other end of the ropes was taken outside the moulding

box, so that the gases evolved would be able to leave the mould through the cavity created. It was envisaged that once pouring would start, the wax rope would burn and the cavity thus created would ease out the mould gases outside the mould cavity.

As expected, the fan thus poured qualified in the radiography test. As per the analysis done later, no alternative method was able to yield the fan casting passing the radiography test and that the usage of the wax rope was the only effective way.

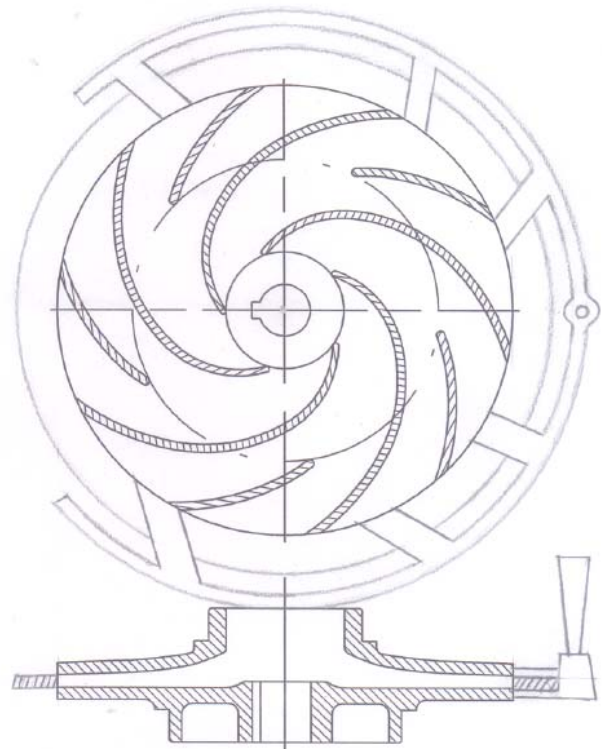
In a big captive foundry setup in west India, there was a huge export requirement for bigger impellers. In smaller category of the same, ingates only in the cope or in the drag would result in consistently acceptable casting. Two down sprues were recommended for the bigger impellers. But the foundry setup did not allow pouring through two sprues. Two sprues would reduce productivity. Further, on conveyer, two ladle pouring was not feasible.

In the revised gating system of the bigger impellers, ingates were given both in cope and drag. This allowed metal entry into the mould cavity through the drag below the core. By the time, the cavity under the core is filled up and metal starts going up through the vanes, the ingates in the cope become operative and the remaining cavity is filled up by the metal through the ingates in the cope (above the core). Pouring time was reduced in this pattern of gating making the casting less prone to cold shut.

The above system with carefully calculated gating system avoids cold shut, core breakage and sand erosion as the metal enters the cavity in a lamellar flow.

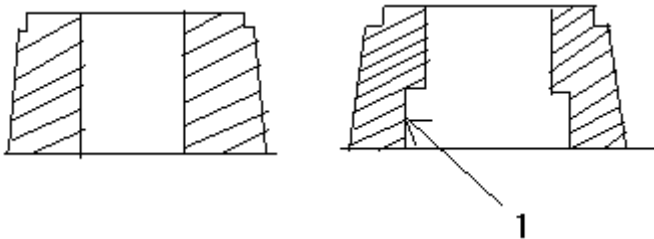
This was the as cast insert.

After machining, it was being converted to B.

Surface 1 was the bearing surface. Here machining allowance was over 5.5 mm on radius.

Therefore, Instead of having a straight internal surface, bifurcation was made in the bearing diameter which was increased in the casting, so that machining allowance here would be to the tune of 2.0 mm and thus the full advantage of the fine pearlite and graphite matrix would be obtained.

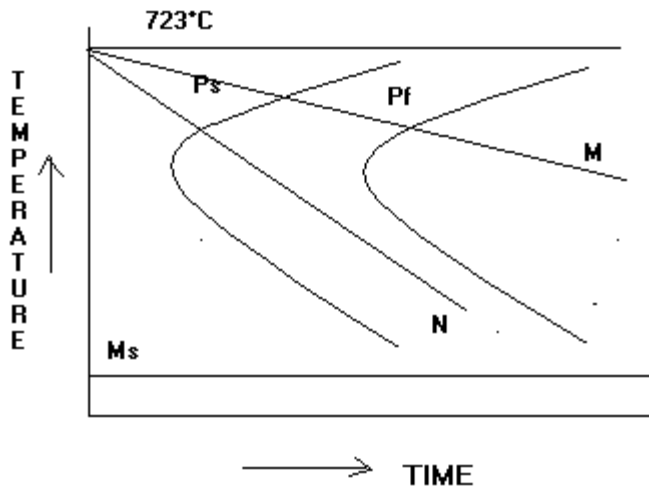
Metallurgically, from austenite, cooling curves (M) and (N) are drawn.

(M) identifies slower cooling curve whereas (N) signifies faster cooling. Faster cooling phase will have compact pearlite and finer graphite flakes as compared to (M), where pearlite platelets will be relatively coarse and graphite flake size will also be bigger. Structure resulting from (N) is desirable compared to that of (M), as in addition to higher strength, it also has improved toughness too. A structure conducive to greater wear resistance thus forms.
