Case Studies: Application of Basic Fundamentals to Solve Foundry Rejection Problems and successful Turnaround Stories

Author: Arun Dongrey, Foundry Consultant

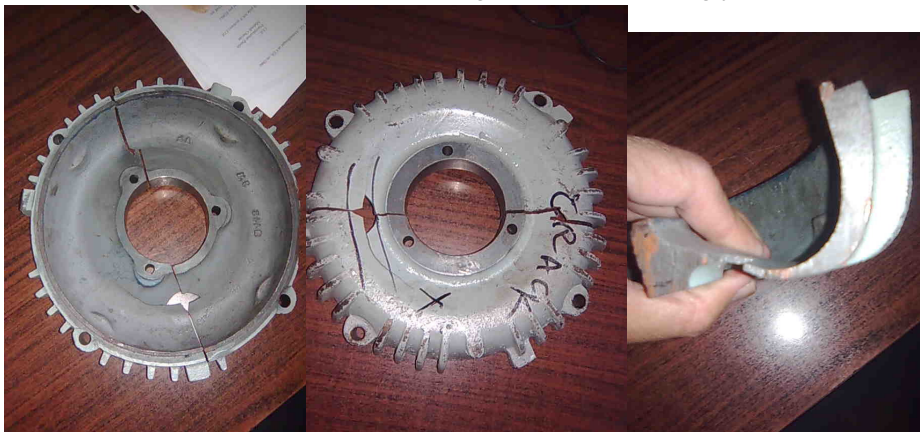
1. **Loom End shield:** This is part of a product of a well known company making generators. The rejection due to cold shut was over 40%. A foundry based in Rajkot was pouring the casting in hundreds, but no one was able to diagnose the seemingly obvious reason.

The foundry applied various gating designs. Higher pouring temperatures were also tried. But all in vain. While the problem was posed for getting a solution, a rejected casting was brought and cut at the defective portion. As was expected, the wall thickness was low, to the tune of 2.8 mm. The drawing showed 4 mm thickness at the spot. The drawing section was advised to consider making the section to 5 mm. The pattern inspection and the molding procedures were improved to ensure that the mould does not sag and the effective metal thickness continues to be 5 mm. This brought down the rejection to a respectable level.

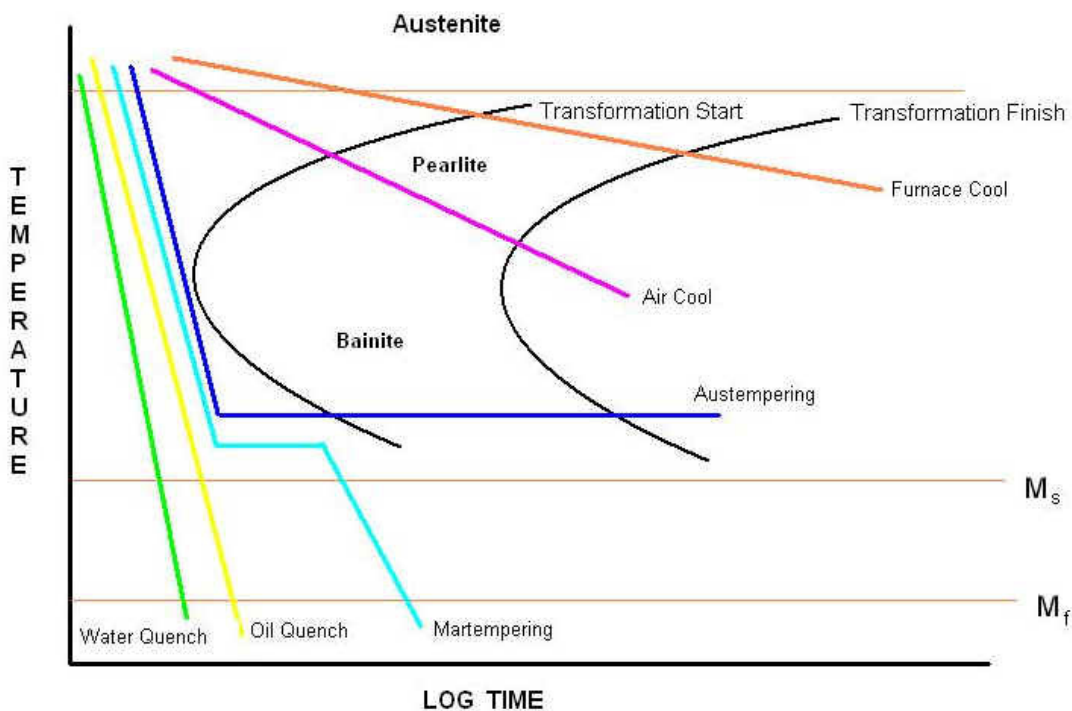
The cooling rate of metal was making all the difference. As can be seen from the TTT curve given below that the metal was to travel half the periphery of the relatively thin casting before it touched the portion required to be punched. The resulting matrix would always be harder than the one with average cooling rate.

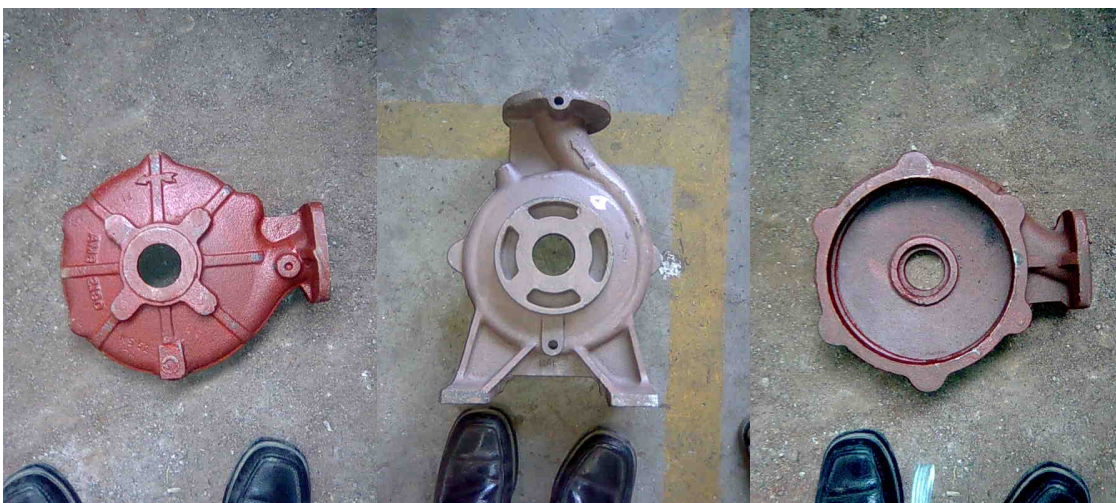
4. **Pump casing castings with and without feet:** They are shown below. In order to reduce additional expenses on patterns, separate pattern is made only for the feet. As per requirements of the customer, this additional attachment is done to the regular volute pattern for getting castings with feet.

B. In the pattern without feet, a conventional gating was given to the body of the casting. When feet were added to the pattern, they would continue with the earlier gating. In the casting poured (with feet), rejection due to cold shut was on a high side. Higher temperature of the poured metal did not solve the problem.

When the runner bar was extended and an additional ingate was given to a foot, the problem was solved. It should be borne in mind that the heavy feet required substantial metal and the pouring time would be on increase. When ingates were introduced even at the feet, metal flow rate improved and the cold shut problem was solved.

When casting weight increases (due to feet in this case), pouring time will increase, if the earlier gating is continued. Gating system should be modified so as to ensure that the pouring time does not increase inadvertently. Additional ingates at the feet and flange solved the problem.

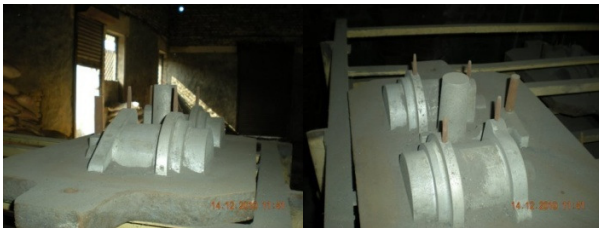
5. **A casting rejection over 25% due to slag inclusion and cold shut:** A particular foundry in Haryana had been producing different types of castings of a particular family. But, over 50% boxes leaked while pouring. The molders would stop pouring due to leakages from the parting line. After the leakage subsided, they would resume pouring to fill the mould. But, due to this discontinuance, slag in the gating system would enter the mould cavity and further, many castings used to develop cold shut. After closing the moulds, weights would be put on moulds before starting pouring. There were no proper mould venting. As pouring started, air in the mould cavity would be replaced by hot metal. In absence of effective vents, when hot metal entered the cavity at high speed, the already present air in the mould cavity would be instrumental in lifting the upper mould. This would result in mould leakages as mentioned above. Obvious remedy was to arrange permanent vents on the match plated patterns. After individual mould was made, it would be made to stand on the flask wall and vents would be opened by vent bars manually to allow effective air evacuation while the pouring started.

As can be seen from the above sketch that vents are provided at specific spots on the pattern. Due to machine molding and squeezing, heights of the flow-offs were limited to a level about one inch below the box height.

In order that the mould air is effectively driven out of the mould cavity while starting pouring, vent diameter and number should be sufficient to allow the air exit equal to the volume in-flow of the hot metal. With this in mind, each cope box was made to stand on wall after the mould was made and piercing with a vent bar made the vent throughout.

The results were extremely encouraging. The rejections fell down to below 10% level from the earlier levels of over 25%.
